PLAINVILLE, CONNECTICUT 06062

DATE Dec. 1981
NUMBER 90-23-A

SERVICE BULLETIN

INDEX PREVENTIVE MAINTENANCE (REVISED)

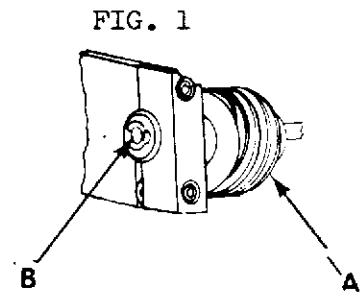
A. Oscillator shaft end play.

PROBLEM: Excessive end play will cause shuttle to go in and out during operation causing loss of loop and continual revolving of loop setter.

REMEDY: Loosen two (2) set screws on worm gear (A). Place a screwdriver at end of oscillator shaft Point (B) to hold shaft in place. Insert allen wrench in one (1) set screw in worm gear and push lightly against collar and tighten both set screws.

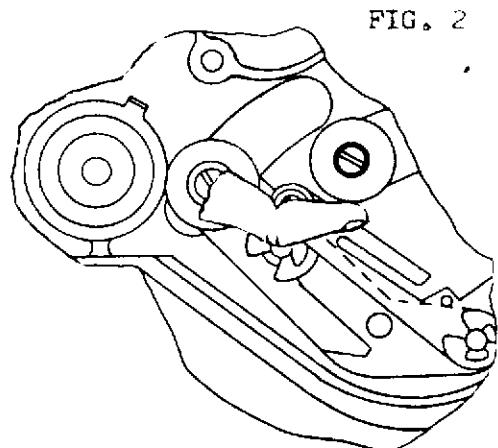
B. Gate Lever operation.

PROBLEM: Improper operation of Gate Lever will not set the required loops causing projector to shut off upon turning the Control Knob.

REMEDY: Raise Gate Lever to full open position. Lower Gate Lever slowly until rear shoe closes. Check lower loop setter to see if it can be released very easily by lifting it with finger. (Refer to Fig. 2). It should be firmly in position. If it releases by applying a slight pressure, press lever (A) Fig. 3 in towards casting slightly so that lever will be seated properly on catch (B). Continue to lower Gate Lever slowly until lower loop releases then press on top loop setter to be sure it is securely seated.

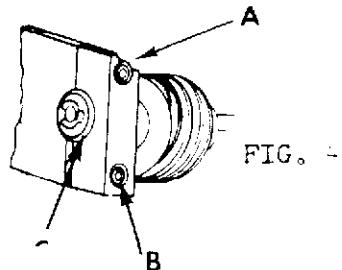
C. Bearing at end of Oscillator Shaft.

PROBLEM: Loose bearing will cause excessive shuttle protrusion.

CAUTION: Excessive tightening will cause the mechanism to bind and run unevenly.

REMEDY: Tighten top screw (A) securely. Tighten screw (B) just tight enough so that the bearing will not move. Do not overtighten. The best method to check this is to insert shuttle adjustment wrench at point (C), and with excessive pressure the bearing should not move. If it does, tighten Screw (B) until the bearing doesn't move. (Refer to Fig. 4)

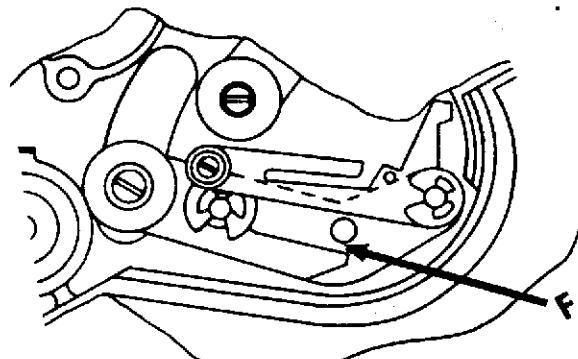
FIG. 5

D. Check Pinch Roll pressure.
PROBLEM: Garbled sound.

1. Rotate Control Knob to Forward operating position. There should be approximately 1/8" clearance between Pinch Roller Arm Assembly and stud on Pinch Roller Actuating arm. (Refer to Fig. 5)
2. If you do not have this clearance, perform the following:
 - A) If serial number of projector is below 920-6587, replace Cam Bearing Assembly behind Control Knob. (Refer to Fig. 6)
 - B) To adjust, loosen screw (A) Fig. 7. Rotate eccentric (B) counterclockwise approximately 1/4 turn. Secure screw (A).
 - C) Control Knob may be loose. Tighten. There should be a slight amount of forward motion of Control Knob after knob is in Forward position. If not, remove knob and file about 1/4 off of extrusion on knob. (Refer to Fig. 8)

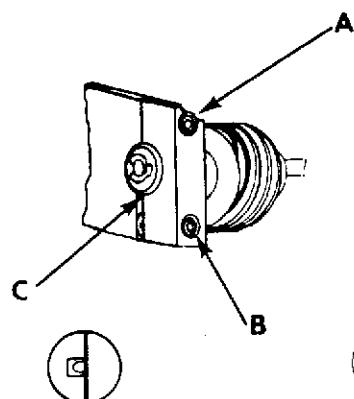
FIG. 9

E. Check Shuttle Protrusion

PROBLEM: Excessive or insufficient shuttle protrusion will cause continual revolving of lower loop setter.

1. Loosen set screws (A) and (B) Fig. 9.
2. Rotate hex end of bearing at point (C) clockwise to decrease protrusion; counterclockwise to increase protrusion. (Use shuttle wrench 53529)

Note: By observing the shuttle teeth, they should retract just below the film channel. Refer to Fig. 10. Setting the shuttle in this manner will allow the shuttle to protrude approximately 1/16" when it advances the film. (Refer to Fig. 11)

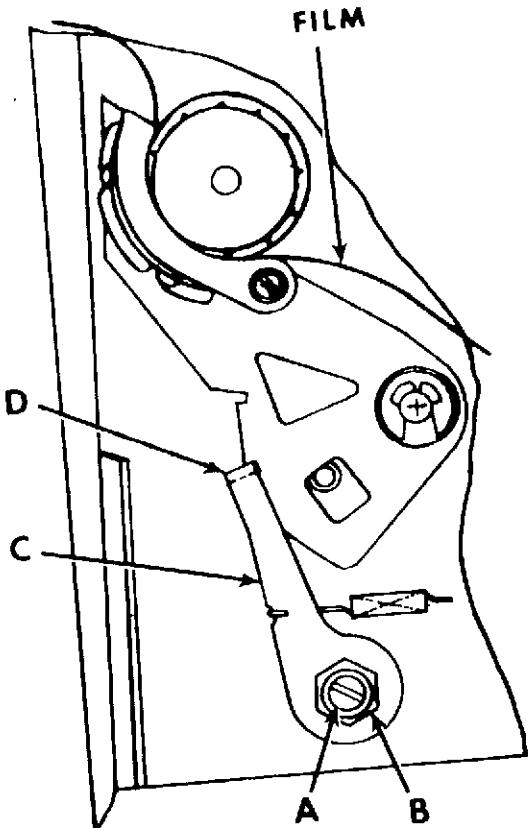
FIG. 12

F. Rear Shoe

PROBLEM: Film slipping through Rear Shoe causing Top Loop Setter Switch to activate turning off projector.

1. Thread projector and close gate.
2. Loosen screw (A).
3. Rotate eccentric (B) clockwise which will raise latching lever (C).
4. Latching lever (C) should just touch top on notch on shoe bracket at point (D) and then tighten screw (A) securely.
5. Raise Gate Lever to full open position.
6. Rotate Control Knob to Forward position and while projector is running film, manually move latch lever to left and then release. It should just clear top of notch at point (D) without binding.

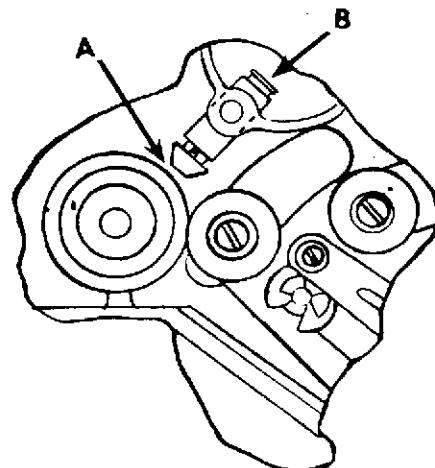
FIG. 16

I. Sound Lens Assembly

PROBLEM: Muffled sound. Low volume.

REMEDY: Remove foreign material from Sound Lens using a pipe cleaner dipped in alcohol. Insert the pipe cleaner between the Sound Drum and the Sound Lens at Point A. Clean the glass disc covering the top of the Sound Lens, Point B.

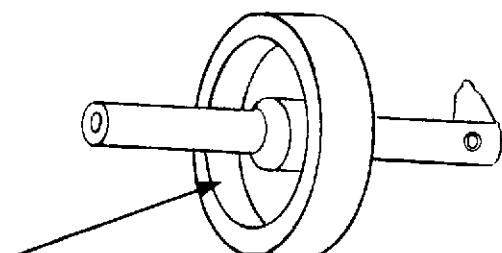
FIG. 17

J. Lubrication of Take-up Spindle

PROBLEM: Excessive tork on take-up.

REMEDY: Remove spindle from Take-up Arm. Apply special lubrication S111-13 on cork. Refer to Fig. 17. (note: we began using this new lubrication on projector serial No. 921-4358)

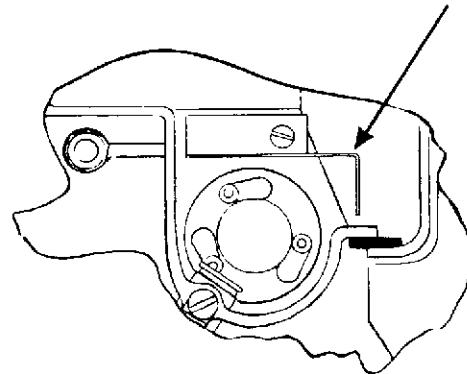
FIG. 19

K. Lamp Replacement Designation

PROBLEM: Incorrect exciter lamp causing low volume.

REMEDY: Place on the exciter lamp shield the self-adhesive sticker #53925. Refer to Figs. 18 & 19.

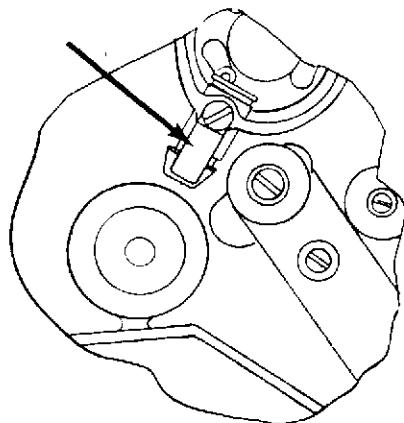
FIG. 20

L. Sound Lens Film Guide

PROBLEM: Film lays against sound lens causing no sound.

REMEDY: Install Film Guide #53924 using screw #S254-832-3. Refer to Fig. 20. (note: we began installing this film guide with projector serial No. 921-3819)

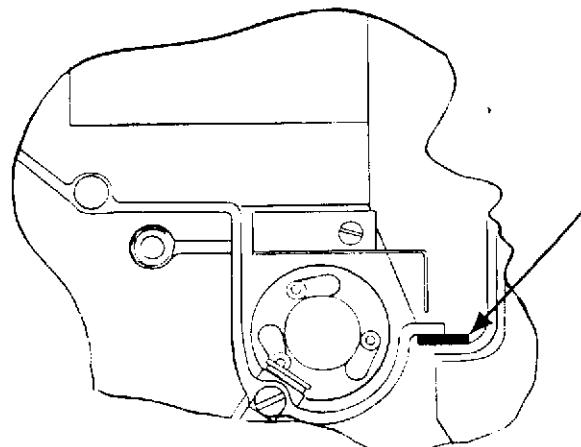
FIG. 21

M. Oil Seepage onto Sound Lens.

PROBLEM: Muffled and low volume.

REMEDY: Place a strip of felt onto casting as illustrated in Fig. 21. (note: this began with projector serial No. 921-4105)
#54172 Felt Strip
